Inspection Report

Property Address: 2345 Mid Mountain Rd Everett, WA

E3 Home Inspections, PLLC

General Summary

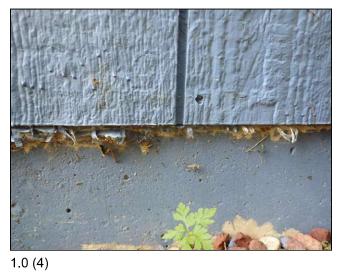
1.0 (5)

1.0 (3) The wood trim needs primer and paint around the home. Recommend a qualified contractor correct as needed.

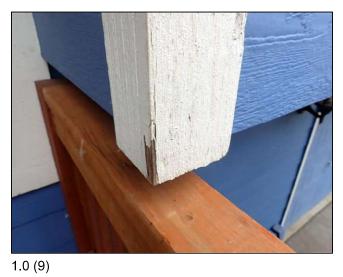
1.0 (10)

1.0 (4) The garage door trim appeared to be damaged in some areas, recommend repair or replacement.

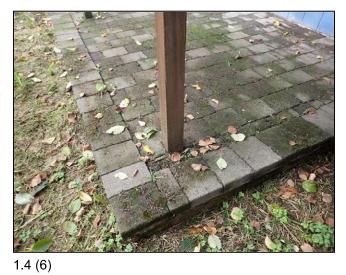
1.4 (4) The deck support posts are showing signs of wood decay, recommend replacement of the damaged wood by contractor.

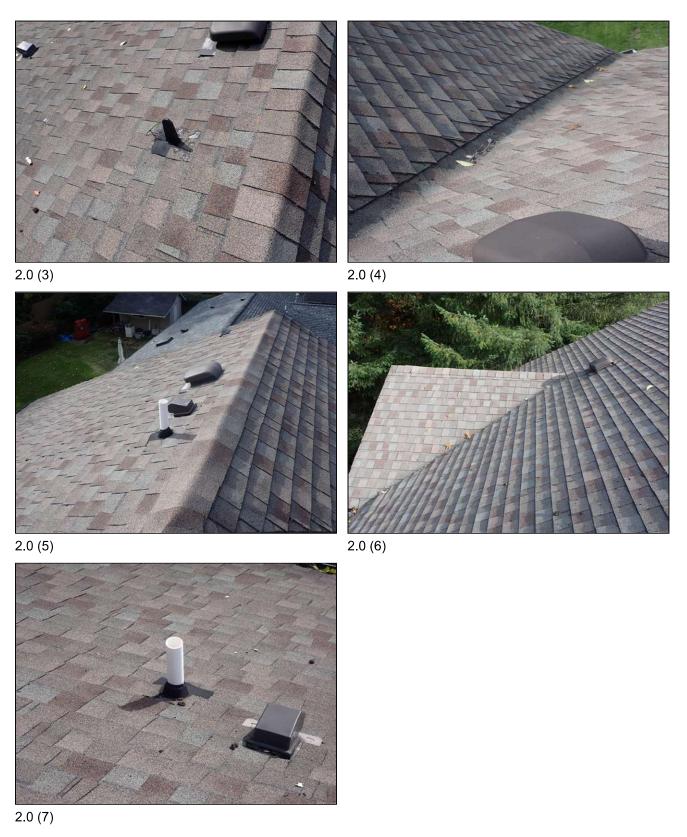
2.0 (1) The roof was showing signs of its age, some granular loss and exposed fiberglass, but was overall in satisfactory condition at the time of the inspection. General photos of roof.

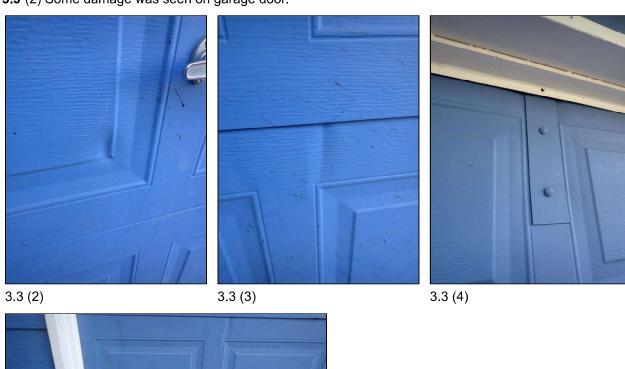
3.3 (5)

3.3 (2) Some damage was seen on garage door.

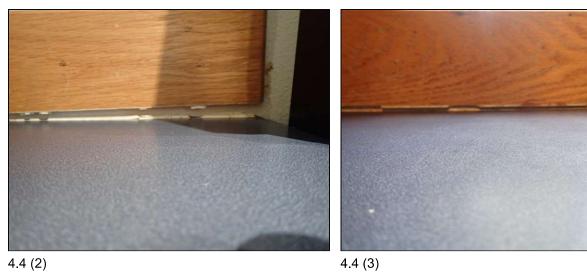
4.4 (2) A gap was seen between the countertop and the back-splash, recommend sealing with caulking, grout, or mortar.

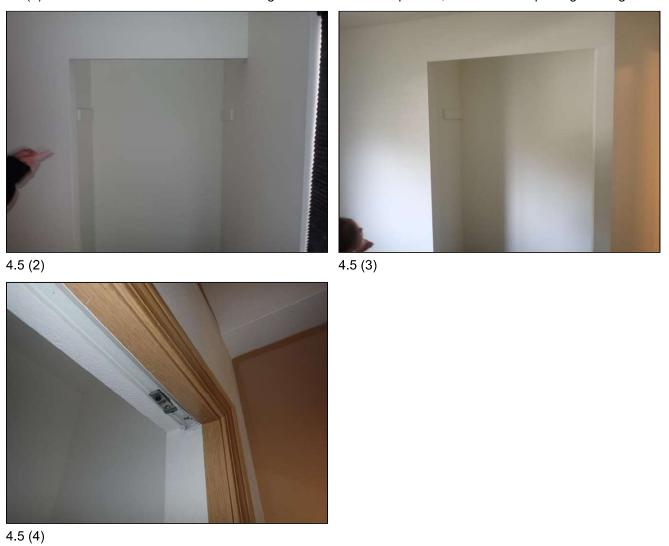
4.5 (2) Some of the closet doors were missing at the time of the inspection, recommend replacing missing doors.

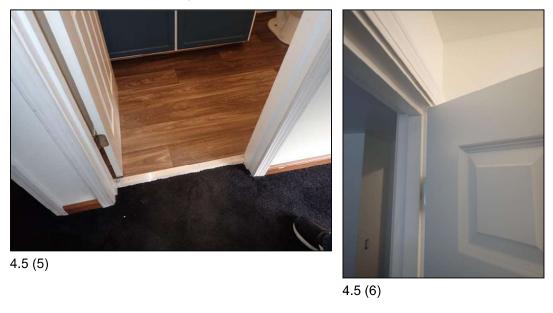
4.5 (3) Some door frames and doors were not properly aligned and would not close or rubbed on the frame, recommend repair or replacement of damaged doors.

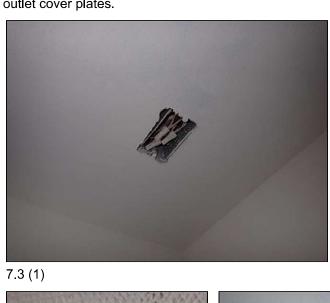
7.3 (2)

7.3 (1) Some areas of the home had damaged or missing outlet cover plates, recommend replacing the missing or damaged outlet cover plates.

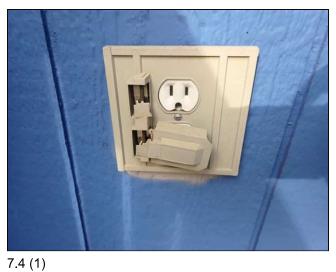
7.4 The outside outlet covers were damaged and need repair or replacement.

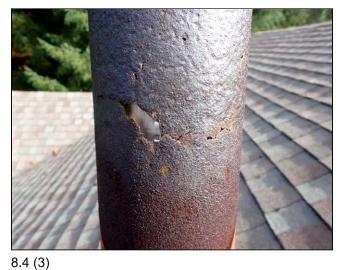
8.4 (1)

- **8.2** Recommend replacing missing grills and registers for the furnace distribution system.
- 8.4 The vent pipe for the furnace and water heater was showing signs of rust and deterioration, recommend replacement.
