Inspection Report

Property Address: 2345 Mid Mountain Rd Everett, WA

E3 Home Inspections, PLLC

General Summary

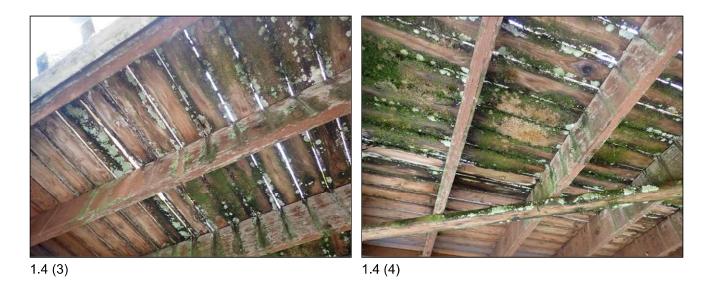
(4) An area of elevated moisture was seen in the attic on the west side of the home. The area may be an indication of a roof leak. Recommend evaluation of the area by roofer and repair as needed.
